AFML-TR-66-12

STRESS CORROSION AND FATIGUE TESTS ON 7001-T75 ALUMINUM ALLOY

THE BOEING COMPANY
Wichita Division

TECHNICAL REPORT AFML-TR-66-12

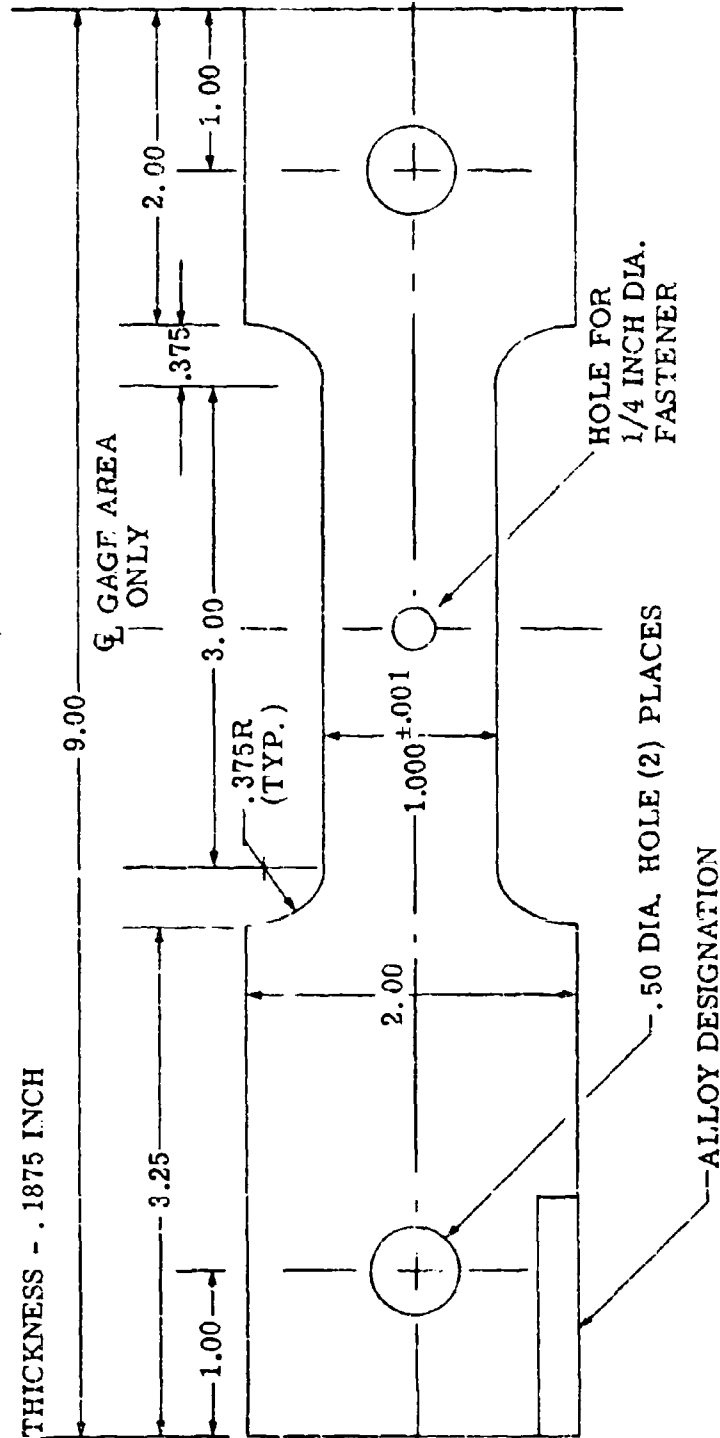
FIGURE 2

RADIUS TO BLEND SMOOTHLY INTO REDUCED AREA, NO UNDER-CUTTING PERMITTED

THICKNESS - .1875 INCH

SPECIMEN CONFIGURATION - STRESS CORROSION TESTS

Specimen configuration and dimensions are shown in Figure 2. When required, holes were cold worked with a tapered steel mandrel of .0053 to .0067 inch greater diameter than the holes. Cold worked holes were deburred on the exit side by breaking the edge approximately .008 inch or 45 degree chamfer. Shot peening, when required, was done with stainless cut wire shot .047 inch in diameter. The specimens were peened all over to a depth of compression of .020 to .025 inch with a coverage of 200 percent. The shot peened specimens were carefully cleaned after peening.

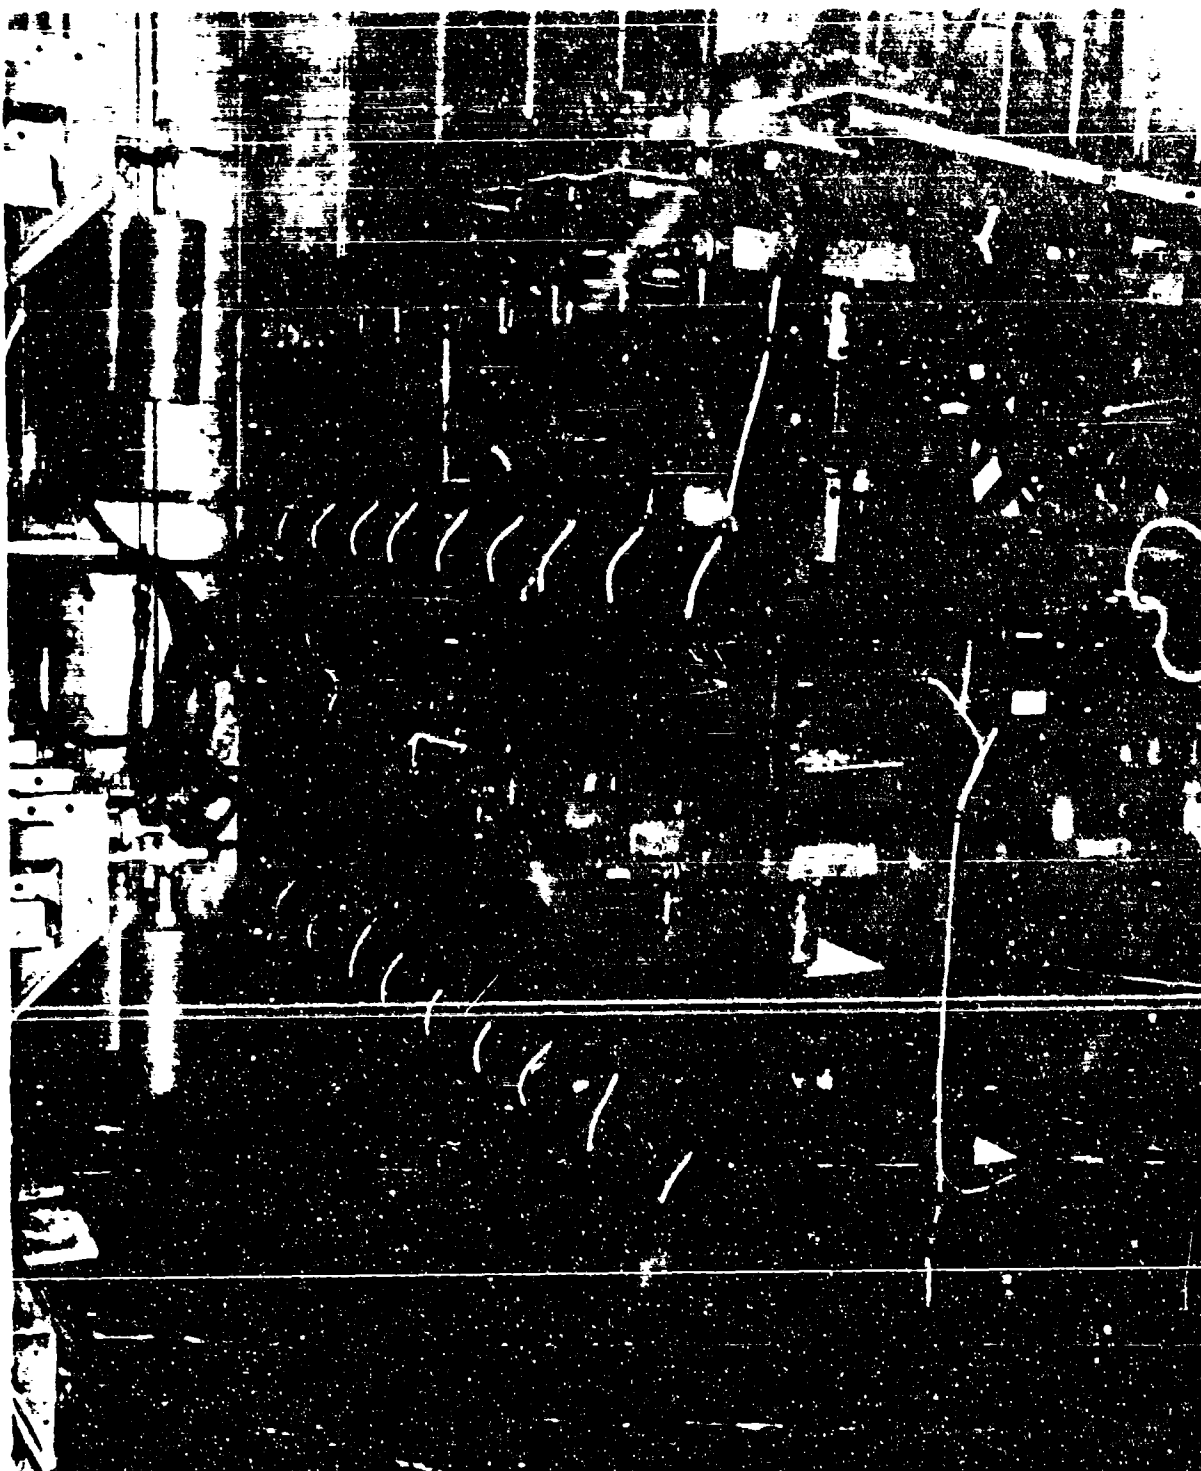
FIGURE 3

CONSTANT LOAD FIXTURE USED FOR STRESS CORROSION TESTING

Specially designed constant load fixtures were used for the stress corrosion tests. The fixtures employed a lever arm arrangement and dead weights as shown in Figure 3. A specimen in the constant load test fixture is shown in Figure 4.

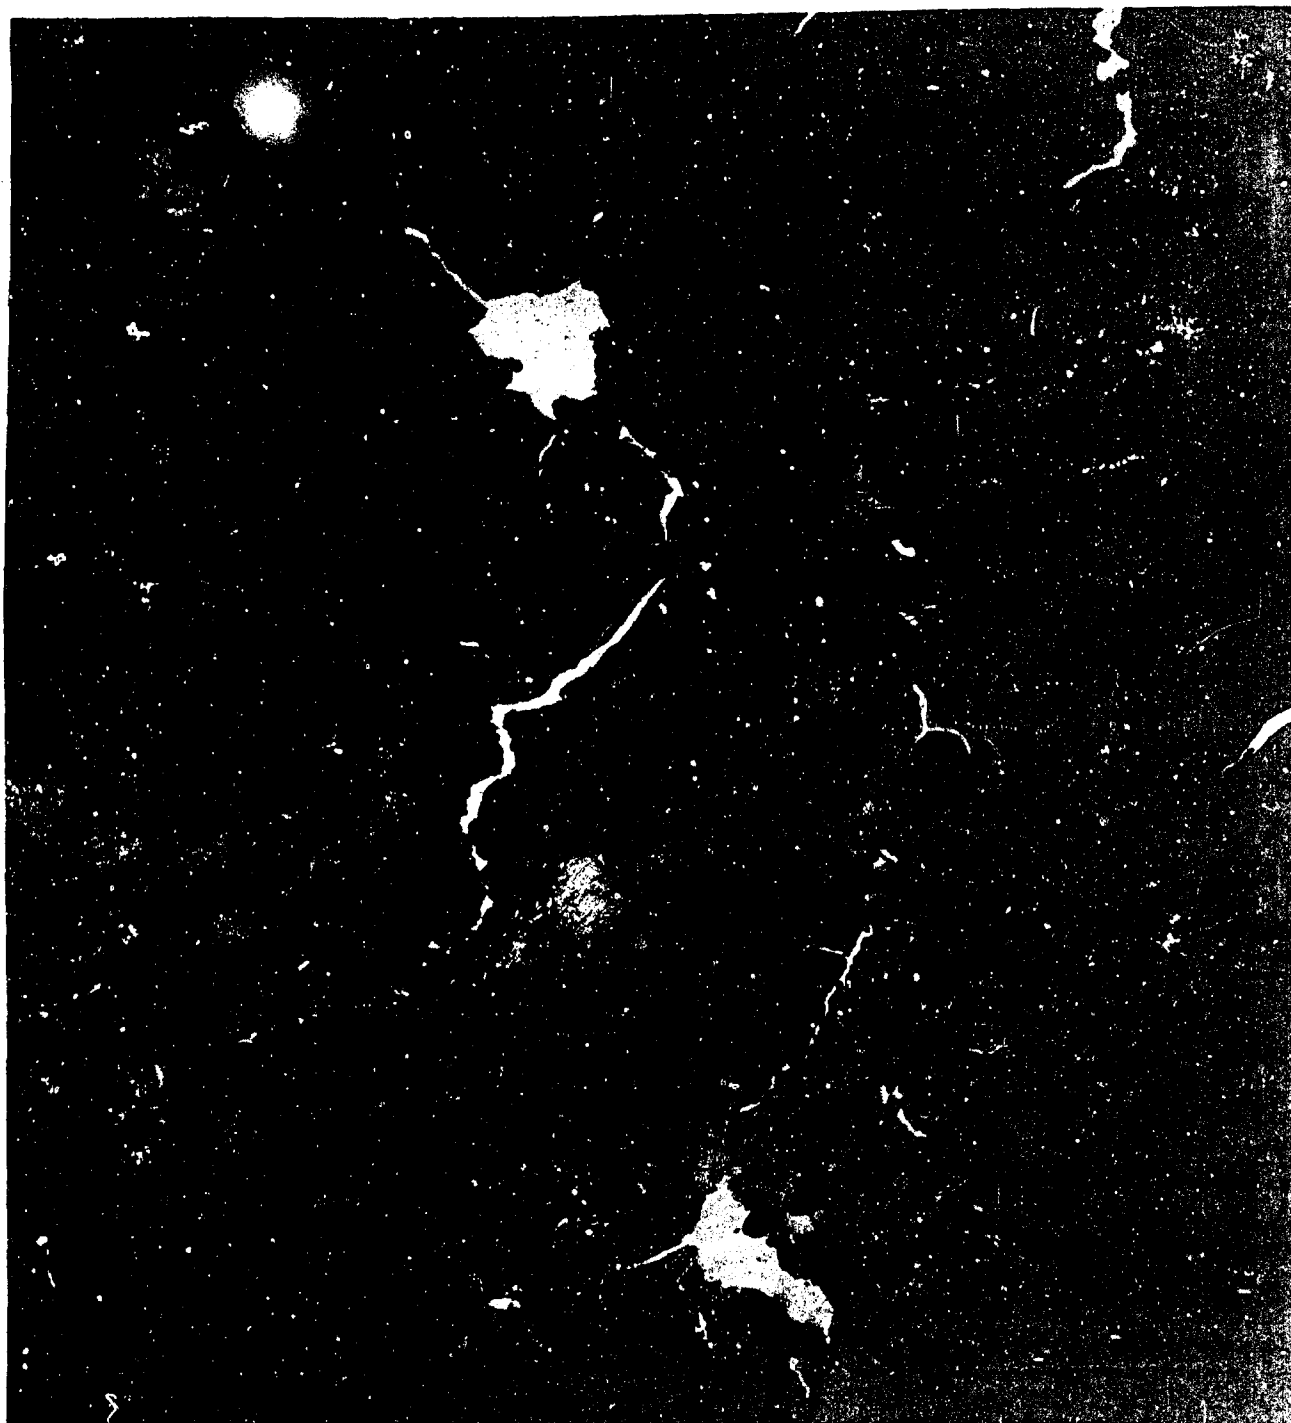
FIGURE 7

10,000X

From two-stage carbon replica of fracture face on Specimen Number 229. Note the intergranular mode of failure coupled with fairly extensive ductile dimpling. This mode indicates that the failure was predominately stress corrosion and tensile overload. This specimen was not shot peened, had a titanium lockbolt installed and had no hole cold work. It failed after 1161.8 hours at 50 ksi (66.7 ksi net area stress).

ELECTRON PHOTOMICROGRAPH OF 7075-T73 STRESS CORROSION FAILURE

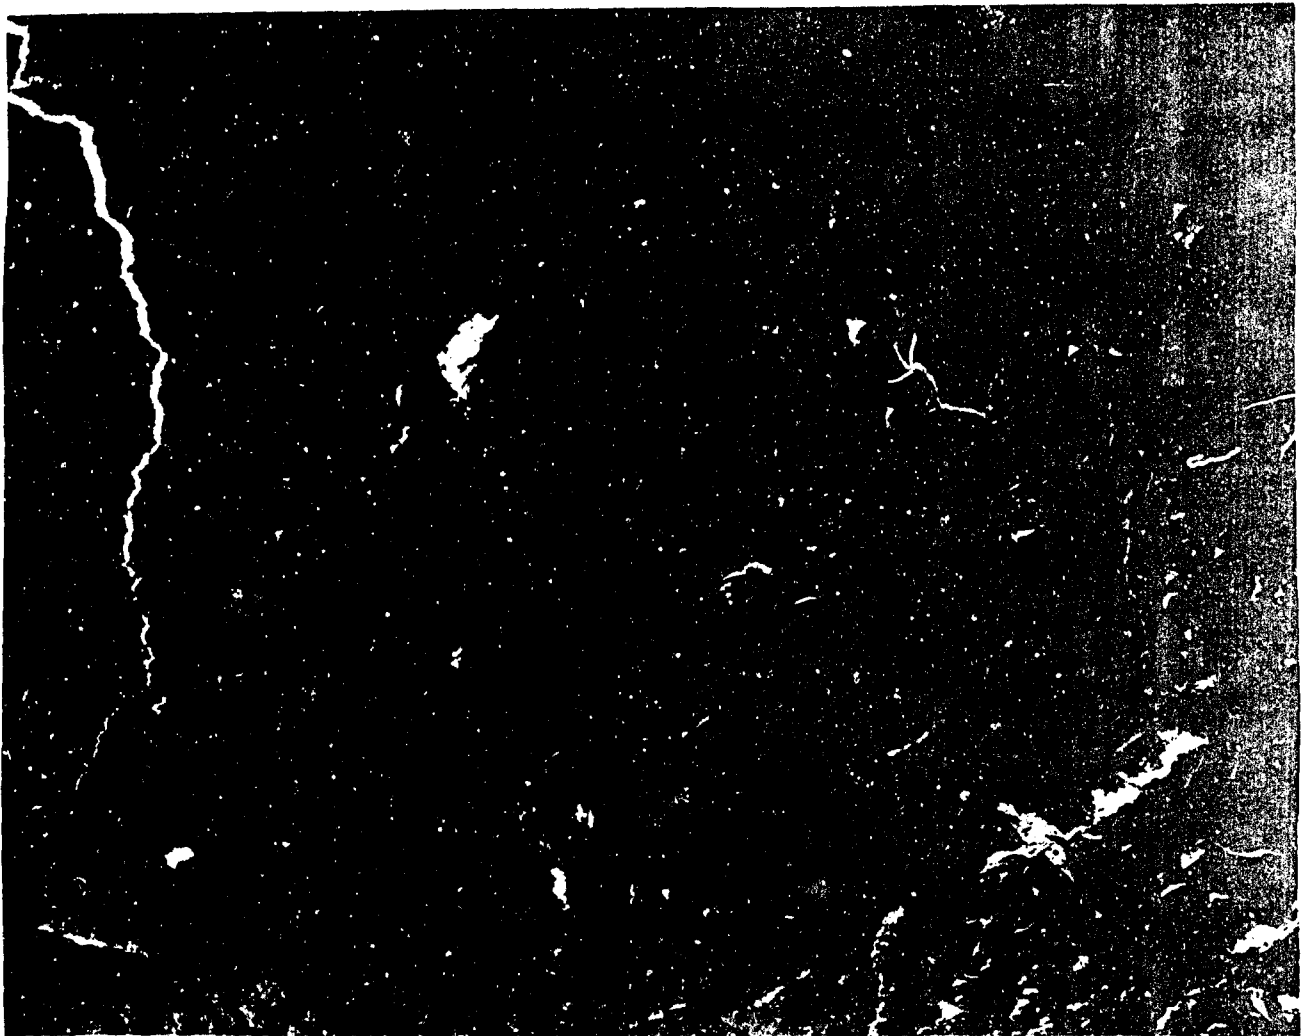
FIGURE 8

15,400X

From two-stage carbon replica on fracture face of Specimen Number 2. The ductile dimpling indicates the fracture mode was overload. This specimen was not shot peened, had a Taper-Lok fastener installed at .0033 to .0043 inch interference and had no hole cold work. It failed after 1992.1 hours at 50 ksi (66.7 ksi net area stress). The area shown was located at the hole-to-specimen surface intersection.

ELECTRON PHOTOMICROGRAPH OF 7001-T75 STRESS CORROSION FAILURE

Figure 8 is an electron photomicrograph taken on the fracture face at the hole-to-specimen surface interface. There is no evidence of stress corrosion in this figure. This indicates that the stress corrosion did not start at this point. Figure 9 shows the typical stress corrosion appearance of the 7001-T75. The intergranular failure mode and the surface corrosion indicated by the black dots is clearly evident.

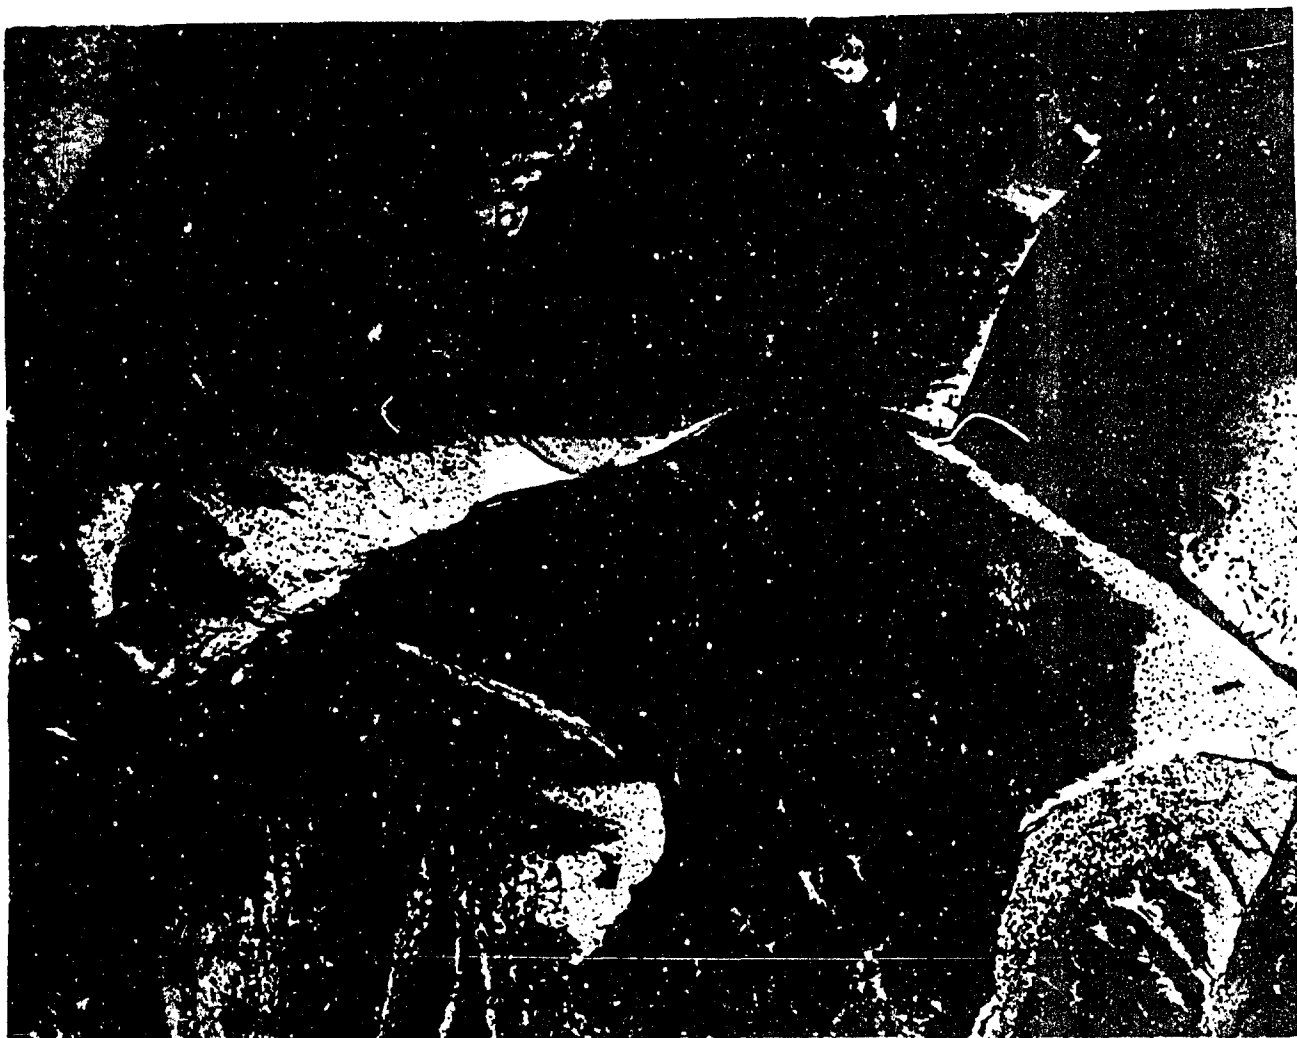
FIGURE 9

6,000X

From two-stage carbon replica on fracture face of Specimen Number 2. The blocky structure and corrosion indicated by the black dots is typical of stress corrosion. See Figure 8 for description of test conditions.

ELECTRON PHOTOMICROGRAPH OF 7001-T75 STRESS CORROSION FAILURE

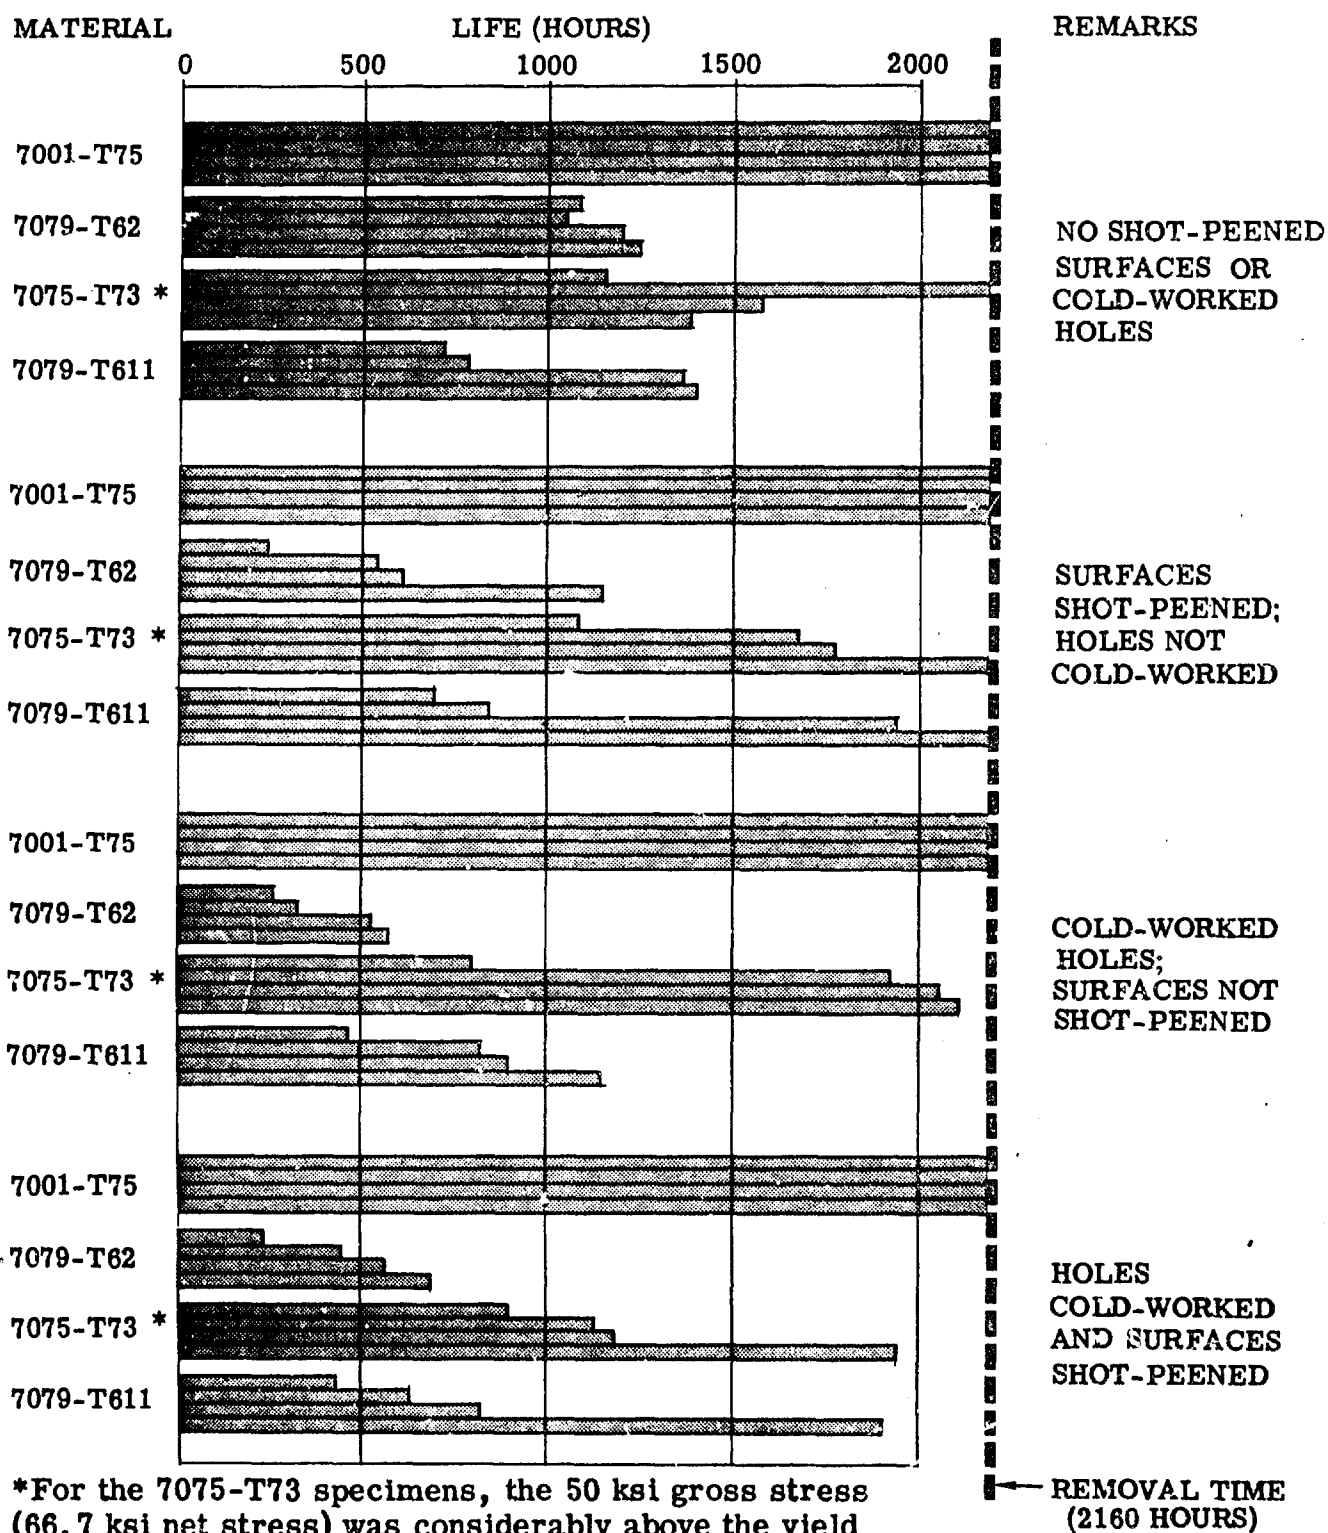
FIGURE 10

STRESS CORROSION TEST RESULTS AT 50 KSI (GROSS AREA STRESS) OF
SPECIMENS WITH 1/4-INCH DIAMETER TITANIUM LOCKBOLTS INSTALLED WITH
.0010 TO .0020-INCH CLEARANCE

Stress corrosion results are tabulated in Tables III through XXVI. A comparison of stress corrosion failure times at the highest stress level, 50 ksi gross, is shown in Figures 10, 11, 12, and 13. An insufficient number of samples failed at the lower stress levels of 30 ksi and 20 ksi to make similar comparisons. A short discussion of stress corrosion results for each of the three gross area stress levels follows.

On examining the data at the 50 ksi stress level shown in Figures 10, 11, 12, and 13, the particular heat of 7001-T75 tested in this program did sustain the applied stress better than the other alloys. As discussed previously, the reason for its seemingly superior stress corrosion resistance as compared to 7075-T73 probably was that the 7075-T73 was operating very close to its ultimate tensile strength. However, the 7001-T75 was clearly superior to all tempers of 7079 tested.

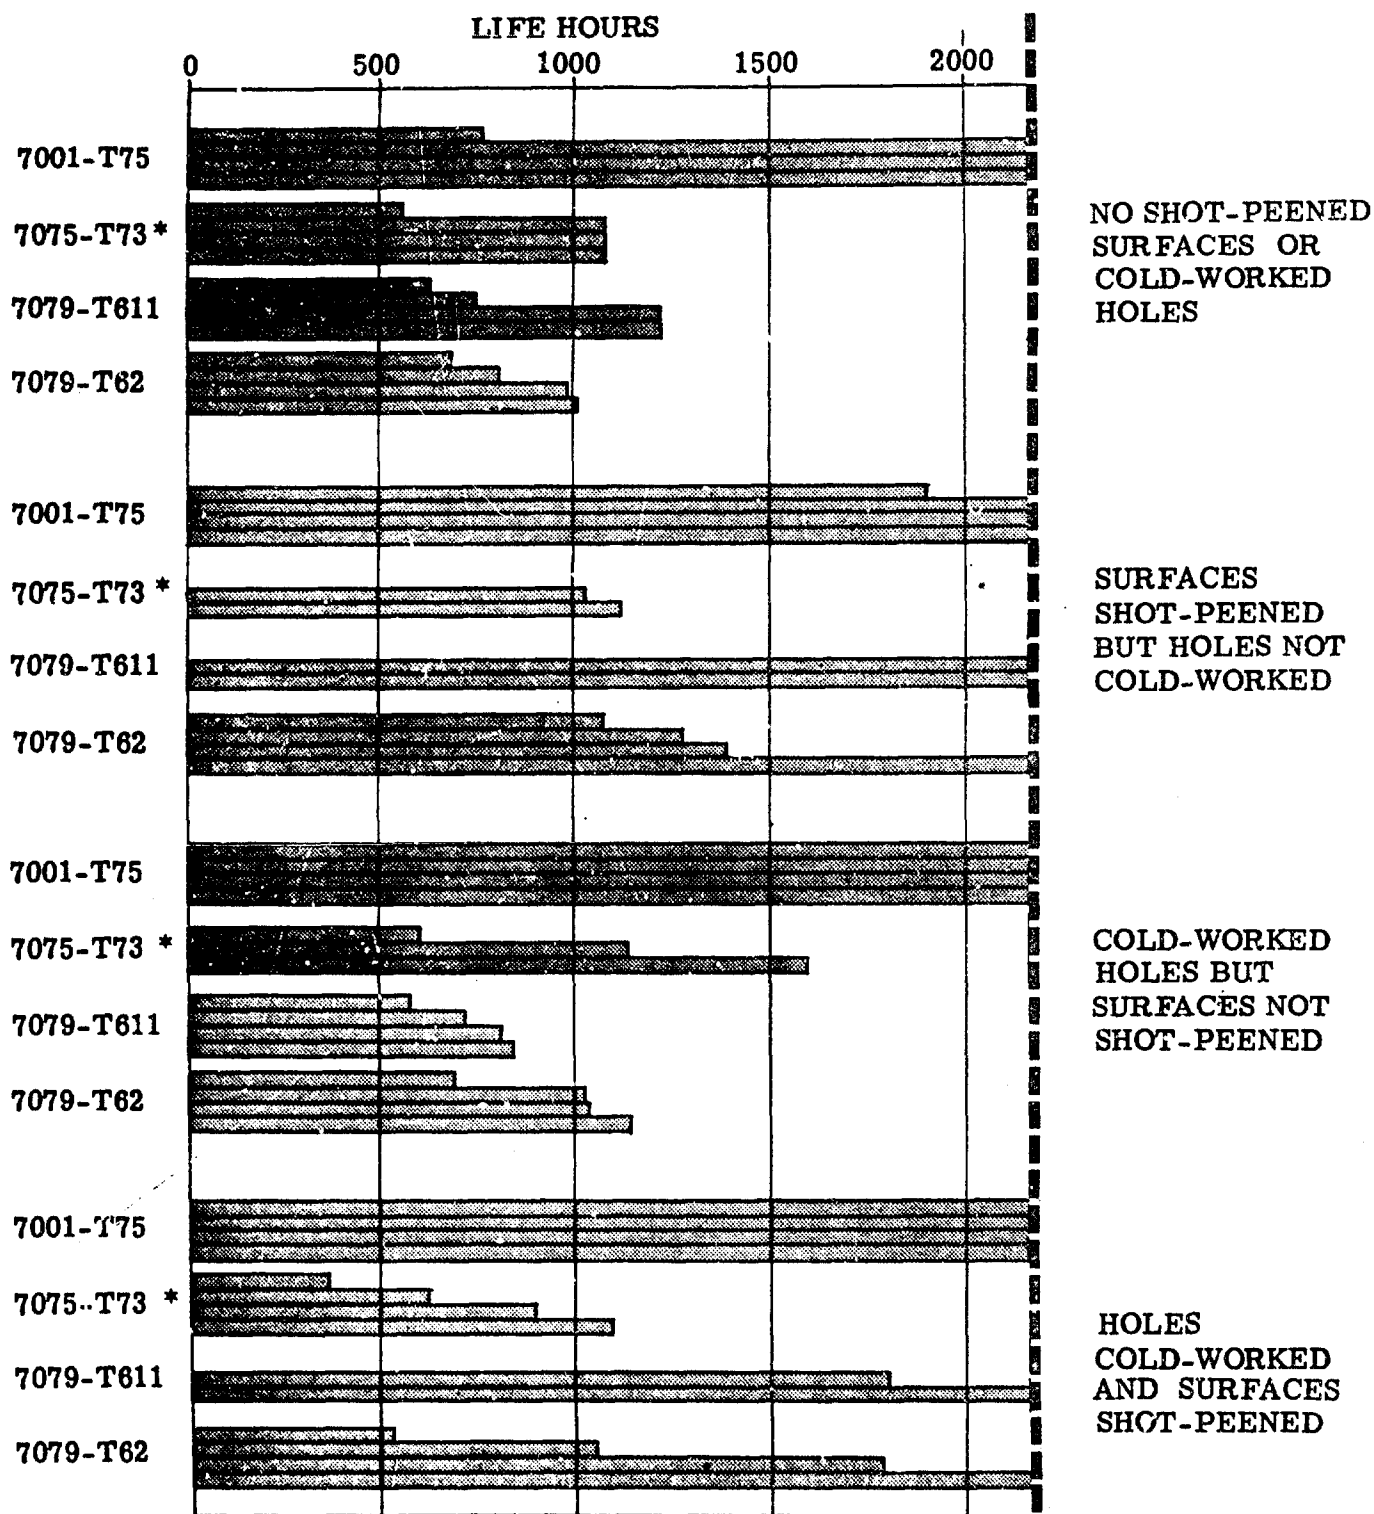
FIGURE 11

**STRESS CORROSION TEST RESULTS AT 50 KSI (GROSS AREA STRESS)
SPECIMENS WITH 1/4-INCH DIAMETER STEEL TAPER-LOK FASTENERS
INSTALLED WITH LOW INTERFERENCE FIT OF .0002 TO .0007**

*For the 7075-T73 specimens, the 50 ksi gross stress (66.7 ksi net stress) was considerably above the yield strength and was just below the ultimate.

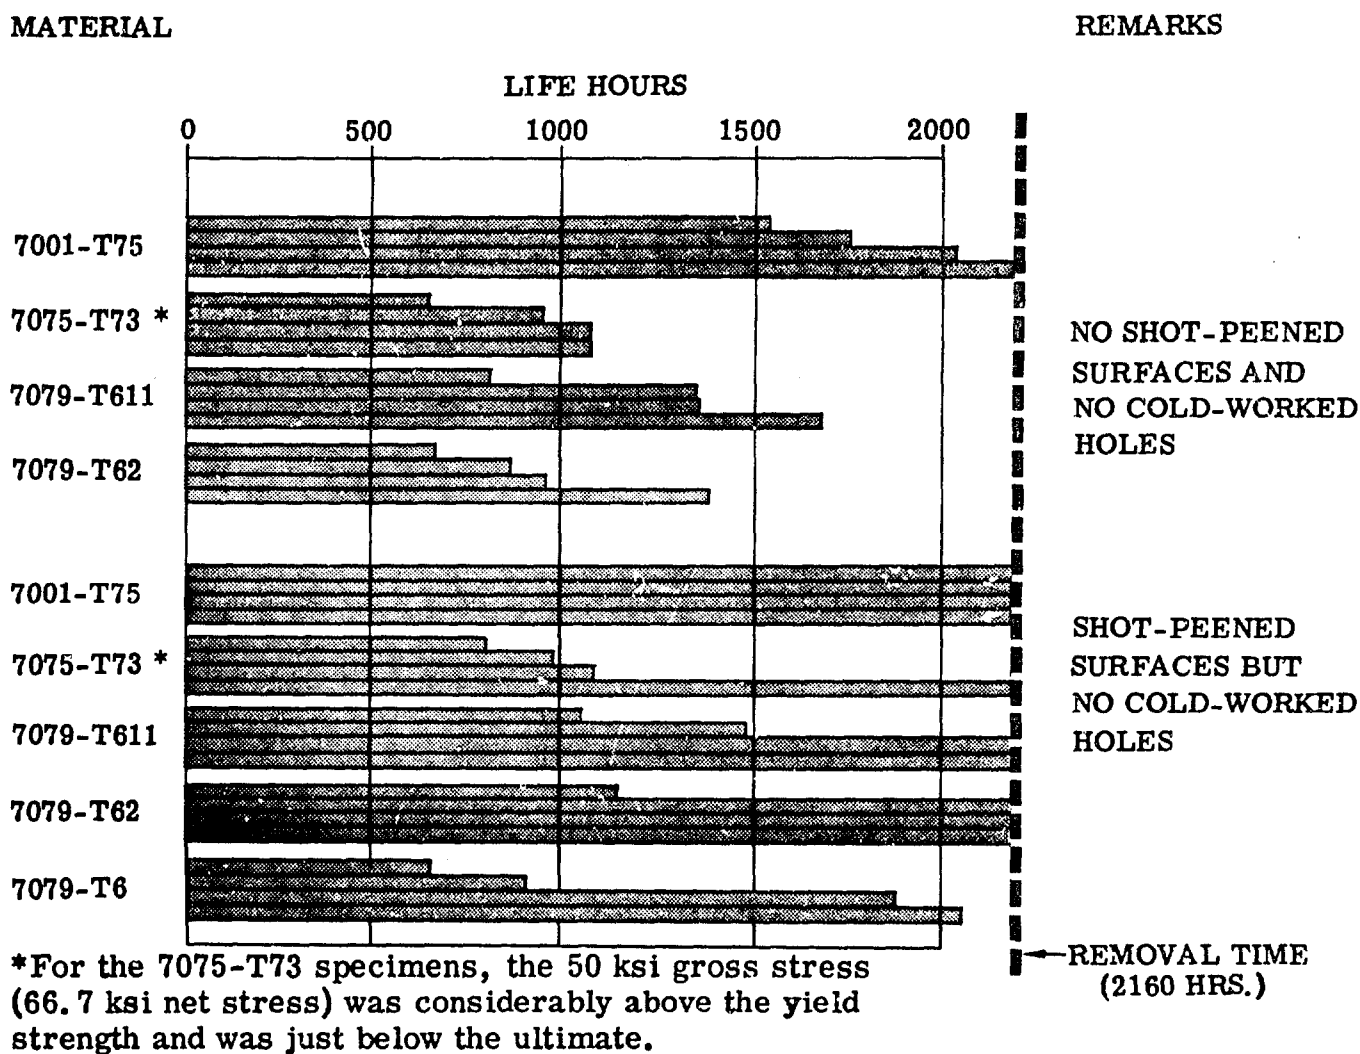
FIGURE 12

STRESS CORROSION TEST RESULTS AT 50 KSI (GROSS AREA STRESS)
SPECIMENS WITH 1/4-INCH DIAMETER STEEL TAPER-LOK FASTENERS
INSTALLED WITH MEDIUM INTERFERENCE FIT OF .0033 TO .0043

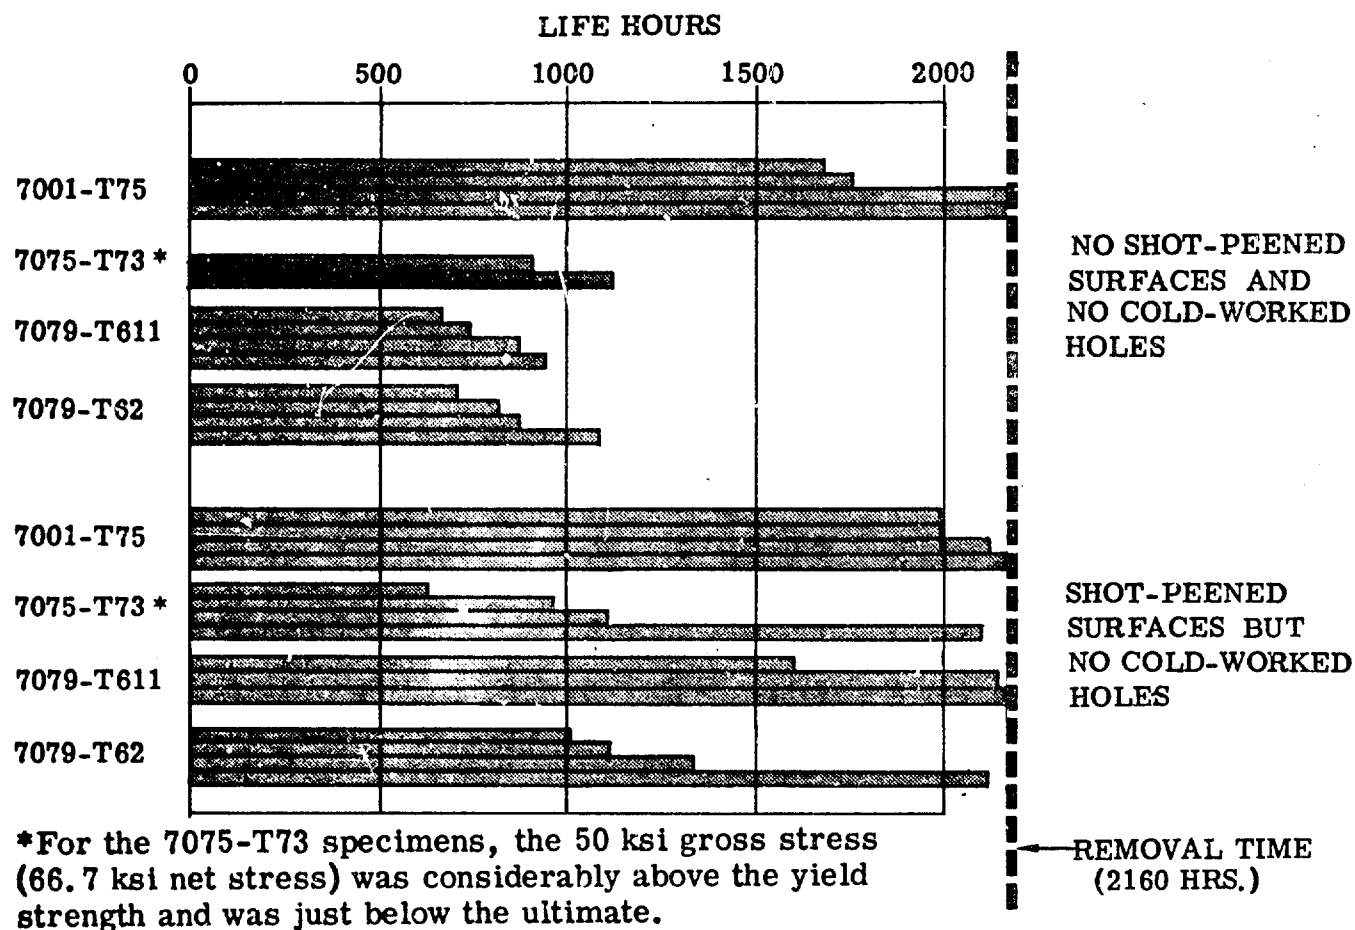
FIGURE 13

**STRESS CORROSION TEST RESULTS AT 50 KSI (GROSS AREA STRESS
SPECIMENS WITH 1/4-INCH DIAMETER STEEL TAPER-LOK FASTENERS
INSTALLED WITH HIGH INTERFERENCE FIT OF .0080 to .0090**

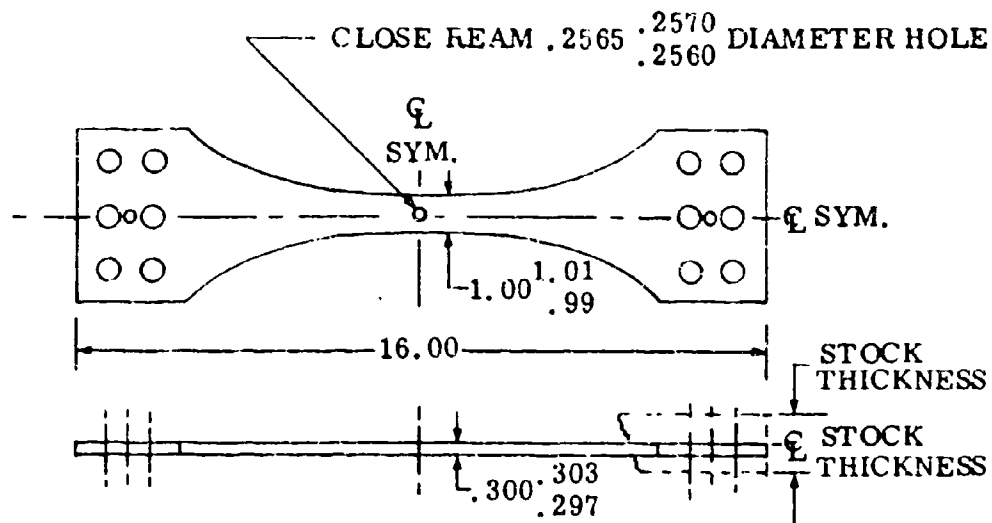
OPEN HOLE MONOBLOCK CONFIGURATION

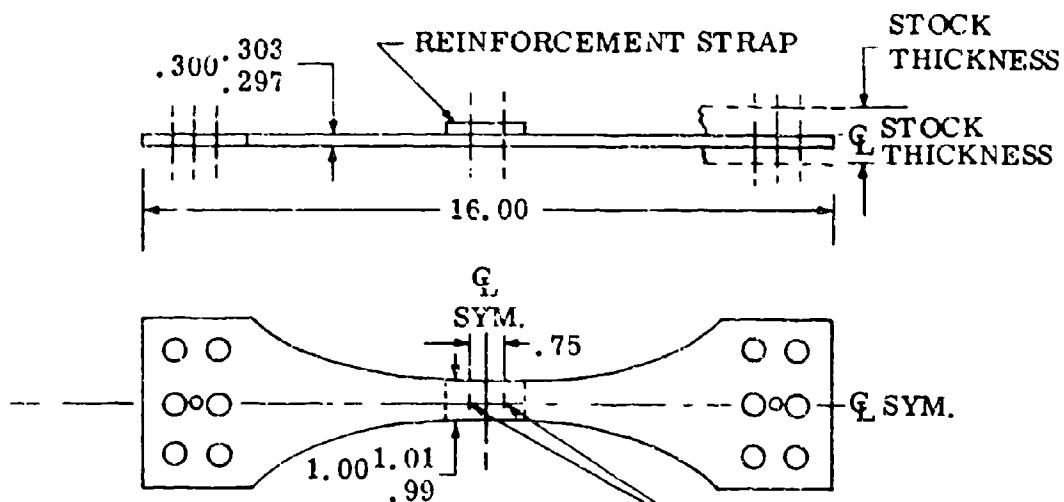
TAPER LOK BOLTS, BAC B30FW-4-9
(.25 DIAMETER), STANDARD INTERFERENCE
(PER BAC 5047), WITH FAYING SURFACE
SEALANT BETWEEN STRAP AND COUPON

STRAP REINFORCEMENT
SPECIMEN CONFIGURATION - FATIGUE TESTS
